**Report of the
Comptroller and Auditor General of India
on
Capacity Utilisation, Electricity Generation, Sale and Collection of
Revenue including Disaster Management by Hydro Power CPSEs
(NHPC Limited, SJVN Limited, THDC India Limited and NHDC Limited)**

**Union Government (Commercial)
Ministry of Power**

**No. 41 of 2015
(Performance Audit)**

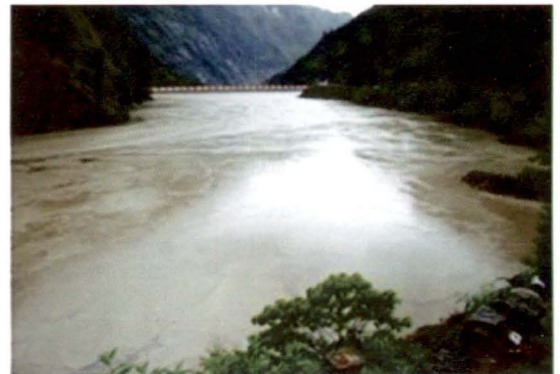
Dhauliganga Reservoir

During the flood of 16-17 June 2013, despite maximum discharge 2051.72 cumecs as against design flood of 3210 cumecs, substantial damages occurred to the power station components viz; power house was submerged up to half the level of office floor (EL 1045 m) and there was heavy accumulation of silt on all the floors²³ the outlet of Tail Race Tunnel (TRT) was choked, four pole structure near the sub-station was washed away; hence grid power supply to power house was not available.

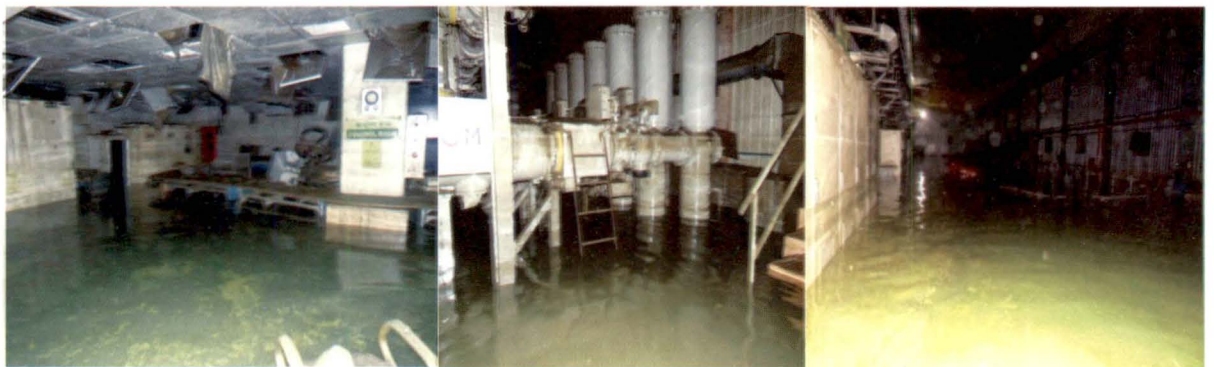
Flooding in Dhauliganga Power House

Besides, eight blocks of B-type quarters (48 quarters) were completely washed away, C and D type quarters, field hostel, co-operative store, nursery school, workshop, colony roads, Central Industrial Security Force (CISF) colony and central store at Dobat suffered severe damages. In this regard NHPC informed MoP immediately after the disaster on 17 June 2013 that due to cloudburst and heavy unprecedented rainfall in upstream reaches of Dharchula area of Pithoragarh District during last two days and subsequent flood in river Kali, water entered the TRT and all systems of powerhouse had submerged in the early hours of 17 June 2013. Besides, a team from NHPC Corporate Office, consisting of Executive Director (Projects), Executive Director (Commercial) and GM (Design and Engineering) who visited the power house site and colony areas of DGPS on 19 and 20 June 2013, submitted its report on 21 June 2013; wherein it mentioned the extent of damages and restoration works required to be carried out. In addition, DGPS prepared (21 June 2013) a report on sequence of events. The reports did not critically examine the sequence of events and adequacy of efforts to mitigate the impact of flood. Restoration activities started from July 2013 with dewatering of power house and three out of four generating units of DGPS were re-commissioned in May-June 2014. Unit no. 1 was put on generation on 22 May 2015.

(v) DMP of DGPS provided that in the situation of flooding of power house, maintenance staff should be informed by operation in-charge for lowering of DT gate²⁶ and as soon as the gate is lowered, the DT drain valve should be opened. However, from the sequence of events recorded in power house just before the flood, it was noticed that at any stage maintenance staff was not asked by operation in-charge to lower the DT gates. Consequently, water entered the power house from TRT and damaged it.

CEA recommended (August 2015) that utilities may undertake suitable measures to avert the flooding of powerhouse.

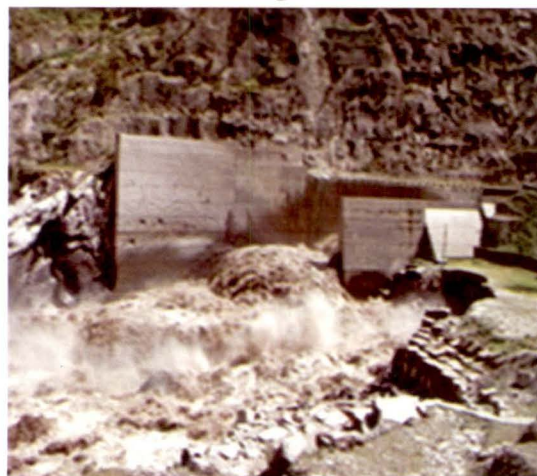
Flood water discharge form Radial Gate

(iv) Flushing operations due in May and June 2013 as per provisions²⁵ of ROM were not carried out despite the fact that till the date of flood (16-17 June 2013) the condition laid down in ROM, for carrying out flushing in June month, of discharge exceeding 150 cumecs was existing from 09 June 2013 to 11 June 2013. ROM further provided that if a flood of magnitude of 500 cumecs occurs, the sediment flushing operation should be conducted. However, despite the fact that river inflow was more than 500 cumecs continuously since 0100 hours of 16 June 2013, DGPS started flushing from 0900 hrs of 16 June 2013 only.

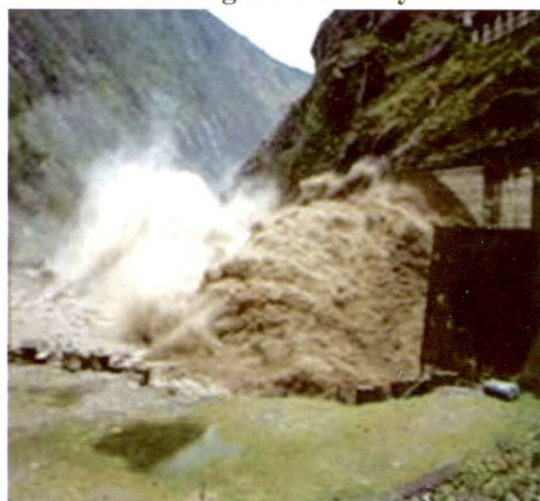
Picture showing the intensity of Flood

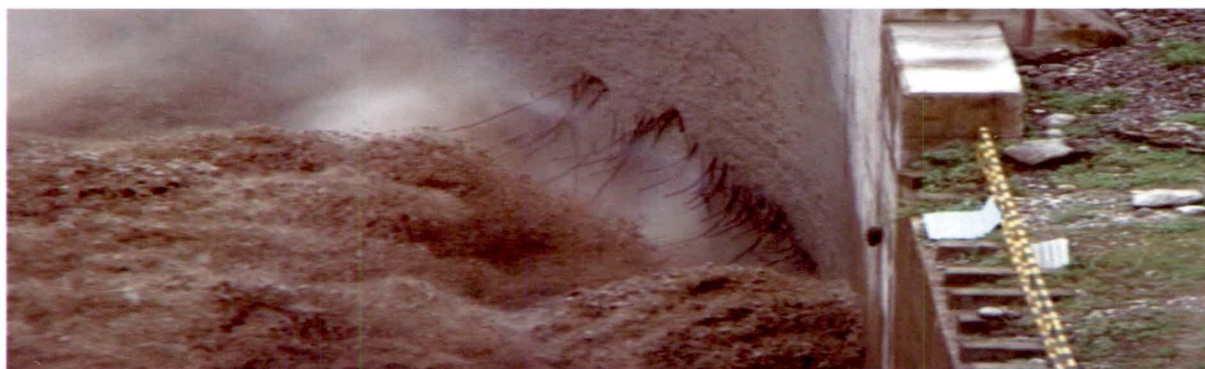
(iii) ROM provided that during monsoon period, the gauges should be observed at an interval of every half hour. Against this, the gauges were being observed at an interval of two hours. Silt level showed increasing trend between 2200 hr on 15 June 2013 (975 ppm) and 0200 hr on 16 June 2013 (1182 ppm); and at 0400 hrs (2450 ppm), it was recorded more than twice the level recorded at 0200 hrs, still the next measurement was taken after two hours.

Damage to Dhauliganga dam site due to flood
