**Report of the  
Comptroller and Auditor General of India  
Performance Audit on Outcomes in Surface  
Irrigation in Tamil Nadu  
for the year ended March 2020**

**Government of Tamil Nadu  
Report No. 5 of the year 2022**

**Performance Audit on Outcomes in Surface  
Irrigation in Tamil Nadu**

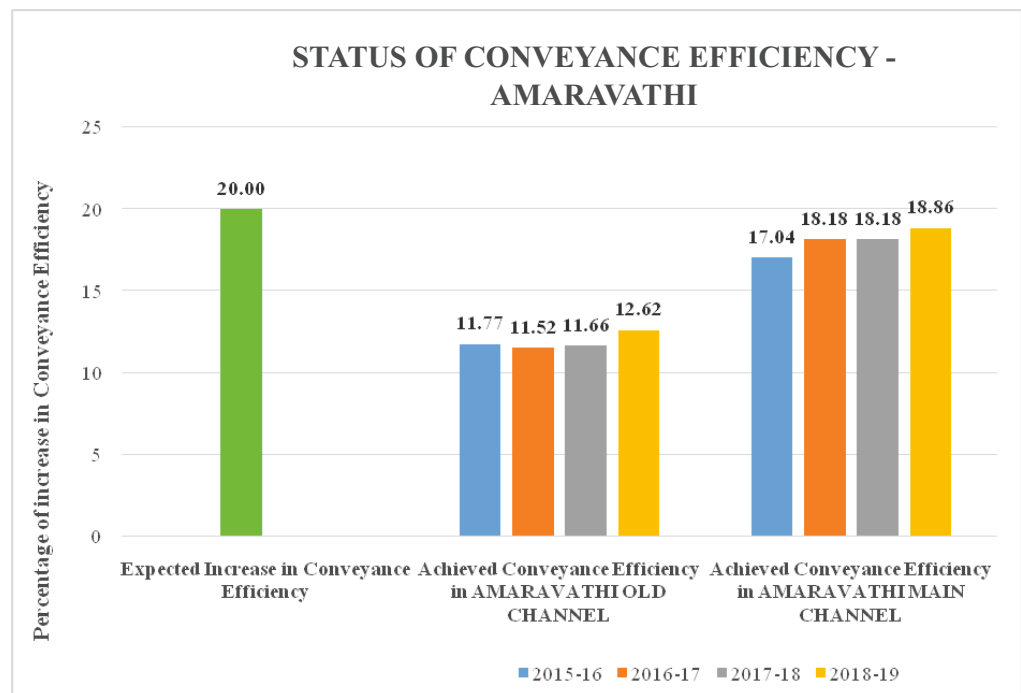
**Chart 2: Status of conveyance efficiency**

Average increase of conveyance efficiency in Amaravathi old channel (earthen channel) and Amaravathi Main Channel (lined channel) against the expected outcome during 2015-16 to 2018-19 is represented in **Chart 2**.

Thus, the intended outcome of increasing the conveyance efficiency of 20 *per cent* was only partially achieved even after incurring an expenditure of ₹ 74.99 crore on channel rehabilitation works under TN-IAMWARM and ₹ 9.72 crore under maintenance works during 2015-16 to 2018-19.

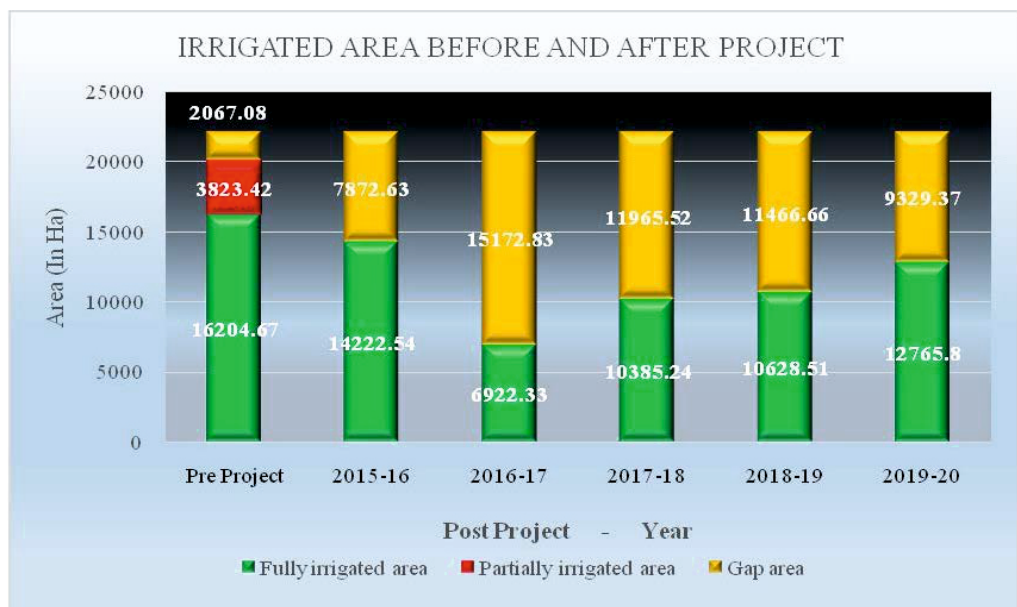
**Chart 3: Pre implementation Vs Post implementation**

Futher, the **Chart 3** exhibits the status of irrigated area and gap area in the Amaravathy irrigation system prior to the implementation of the TN-IAMWARM project and the actual achievement after the implementation of the project.

Audit noted that the actual irrigated area reduced during the period from 2015-16 to 2019-20 which was in the range of 12 to 57 *per cent* of the pre-project irrigated area.

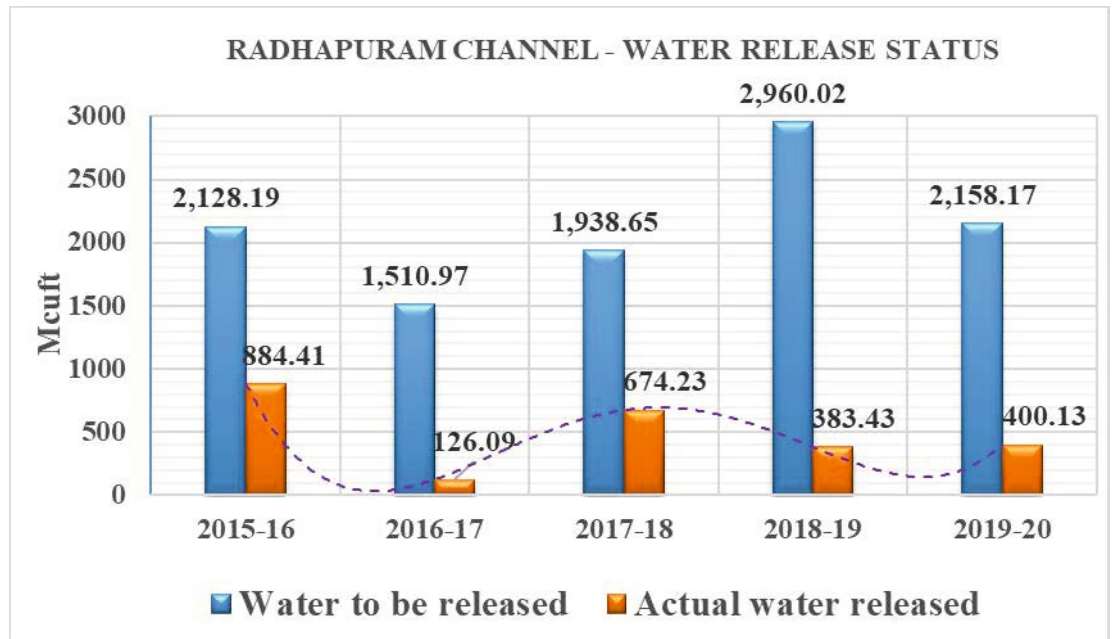
Chart 6: Short release of water

- WRD released only 08 to 42 per cent of the required water for irrigating the target area in the Radhapuram channel during 2015-16 to 2019-20. The short release of water in Radhapuram channel ranged between 58 and 92 per cent. Audit noted that the initial proposal for release of water in the Radhapuram channel submitted by the field officials of the Department to Government ranged between 130 Mcft and 194 Mcft as against the water requirement of 2.5 TMC (as envisaged in the DPR) during the years 2016-17 to 2019-20.
- During 2018-19 the water released from the two dams for the three channels was 22.4 TMC. Of this, the water requirement for the two channels<sup>27</sup> was 16.4 TMC and there was an excess water release of 5.9 TMC. But, WRD released only 0.38 TMC as against the requirement of 2.5 TMC for Radhapuram channel and the balance water was diverted to the other two channels.

Thus, the field officials of WRD failed to propose to release 2.5 TMC of water as envisaged in the DPR required for conversion of gap area. This led to short release of water to the drought prone Radhapuram area and non-achievement of envisaged outcome on conversion of gap area as discussed in **Paragraph 4.4.**

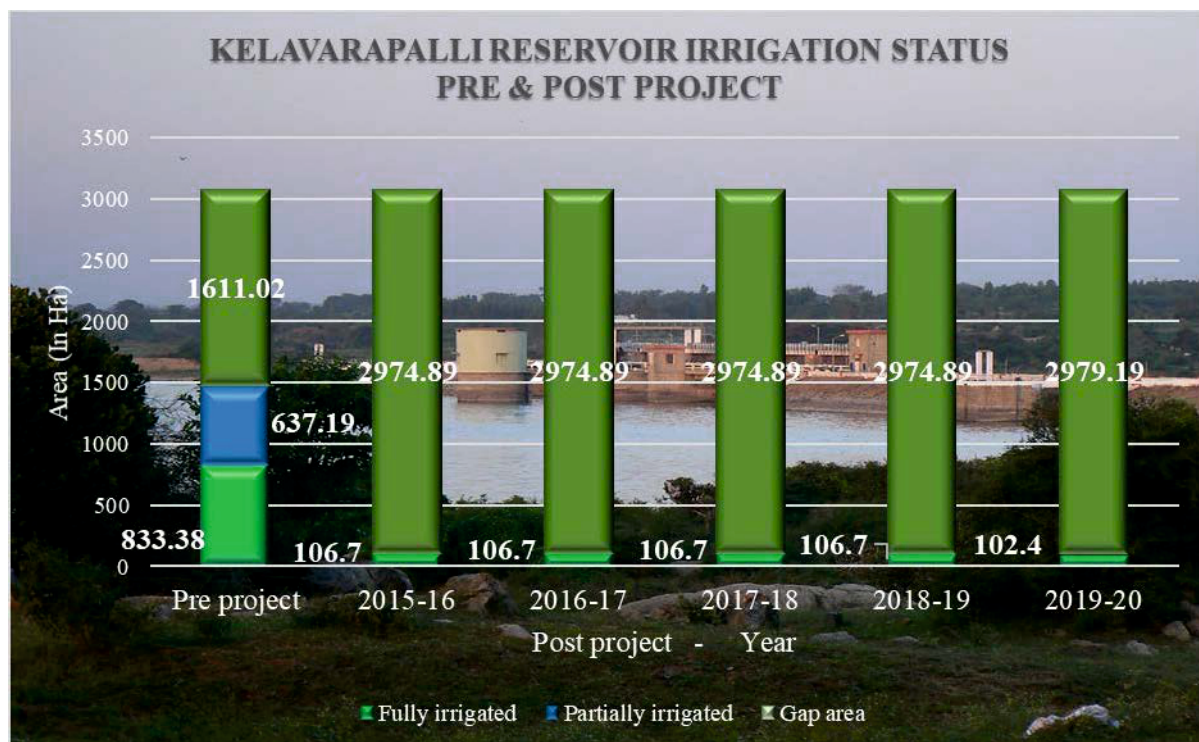
**Chart 8: Pre and Post project implementation status**

The irrigation status in Kelavarapalli Reservoir during the pre and post project implementation (2015-16 to 2019-20) is shown in **Chart 8**.

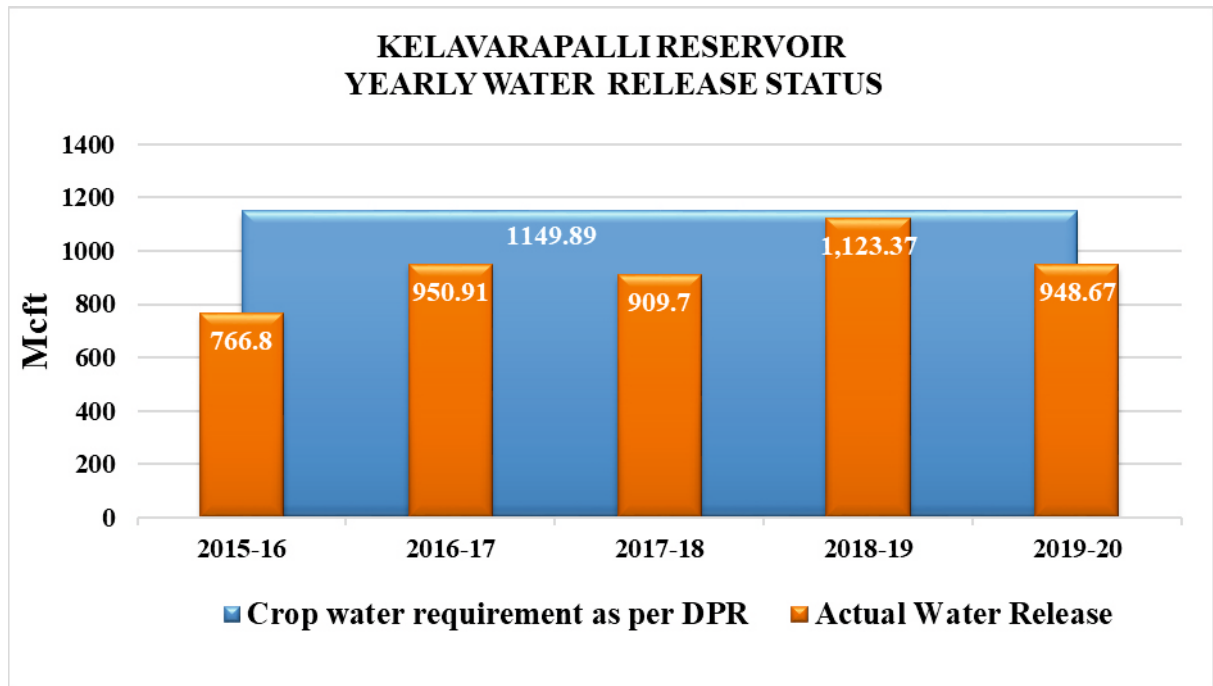
**Chart 9: Water release against crop water requirement**

- As against the orders of the Government for release of 4,421.31 Mcft during the period from 2016-17 to 2019-20, WRD released 3,932.667 Mcft (89 *per cent*) only.
- Despite the release of water from 67 to 98 *per cent* of water required for crops, the actual irrigation was only about 110 ha (04 *per cent*), as against the targeted area of about 3,000 ha. Such a large scale reduction in actual irrigated area indicated inadequate co-ordination of the field officials of WRD with the Revenue authorities and farmers as already discussed in the **Paragraph 5.4**.

Thus, absence of adequate water management, as discussed in previous paragraphs, resulted in non-achievement of the envisaged outcomes of conversion of gap area into fully irrigated area as envisaged in the DPR of the project even after incurring of ₹ 6.60 crore and maintenance cost of ₹ 1.50 crore.

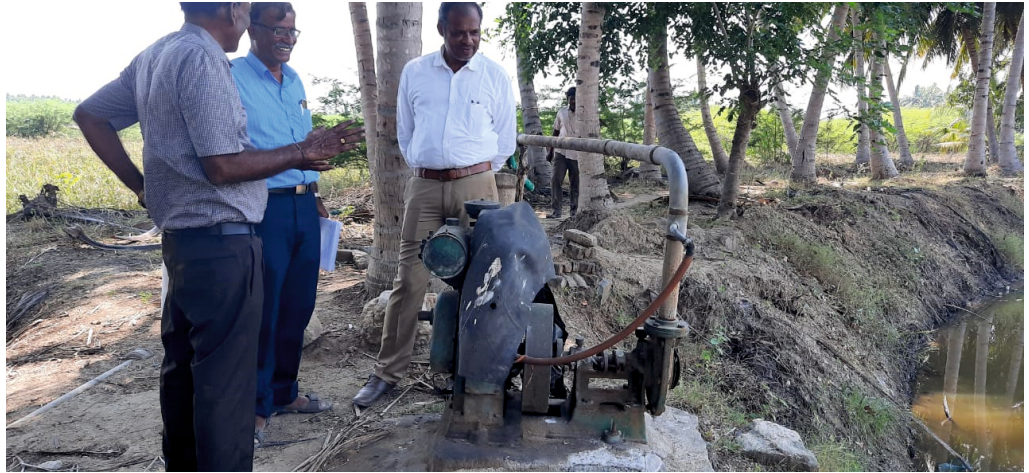
**Figure 2: Illegal drawal of water in Pallapalayam Left bank channel**

- In Pallapalayam Left bank channel, audit noticed erection of a pump set at the upstream of the channel paving way for illegal drawal of water from the channel and it was also noticed that a sluice was in damaged condition.

Department stated that the illegal drawal of water as well as the damaged condition of the sluice was noticed only during joint inspection and action would be initiated for the removal of pump set / rectification of damaged sluice.

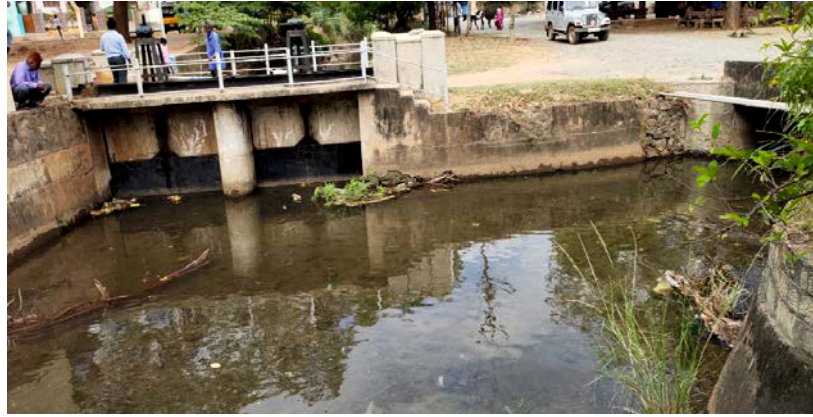
**Figure 3: Water seepages due to damaged shutter**

- Water seepages of five cusecs due to uneven seating of both the shutters of the Head Regulator at LS 0 KM of the Radhapuram channel was noticed and the water was unauthorisedly blocked by stacking sandbags across the channel in the LS 645 and diverted to the corresponding ayacuts.

Government replied (October 2021) that the obstructions causing seepage of water would be removed before the next water release.

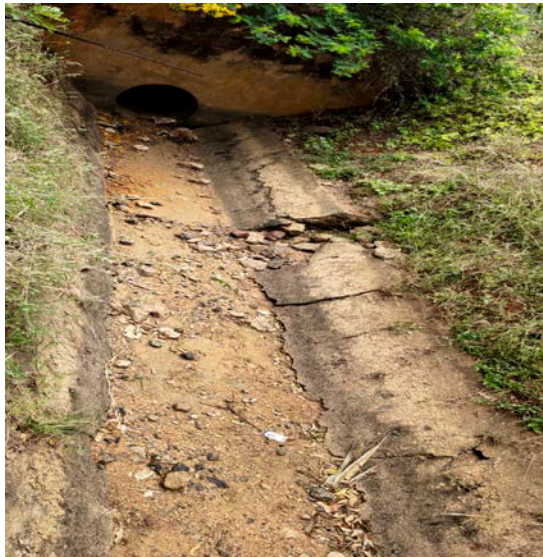
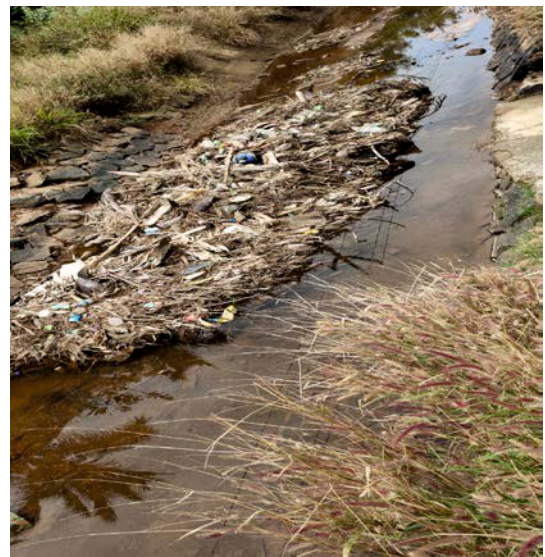
**Figure 4: Damages in the outlet channel**

It was noticed that there were damages in the wall of the main channel which resulted in seepages. It was also observed that there were damages in the out-let channels and used plastic bottles obstructed the free flow of water.

**Plastic waste obstructing free flow of water**

Field officials of the Department confirmed that unauthorised activities were done by the farmers and that action for removal of blockages and rectification of damages would be initiated before subsequent water regulations.

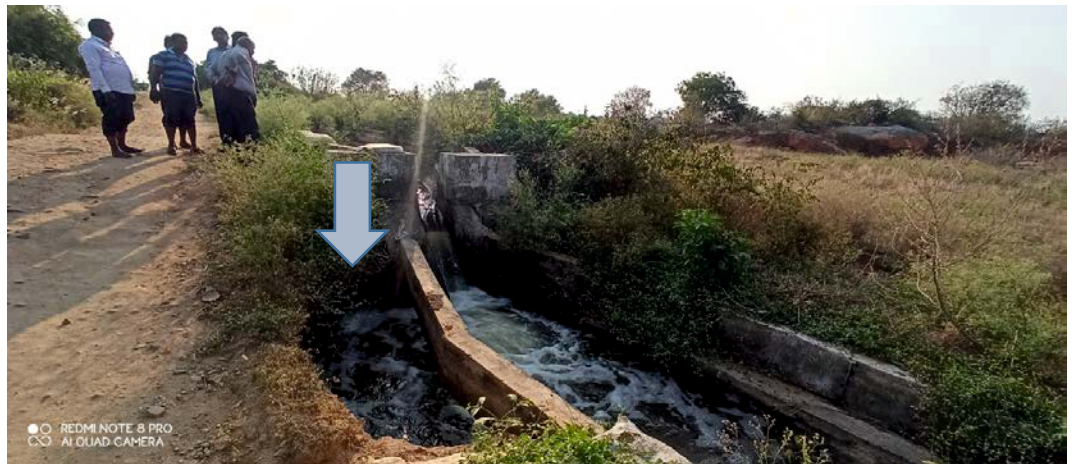
**Figure 5: Breaches in the Channel**

- It was observed that the carrying capacity of RMC channel was not maintained uniformly to ensure free flow of water in the channel. The carrying capacity was 84 *per cent* in LS 755 m, it reduced to 72 *per cent* in LS 1,215m and it increased to about 100 *per cent* in LS 2,908 m. The carrying capacity of the channel reduced flow of water due to obstruction by siltation and seepage of water by damages from the channel.
- Audit noticed illegal tapping of water by the farmers utilising private pumpsets from the main channel (in three places LS 2,908 m, 6,925 m and 6,940 m), siltation with bushes (in three places LS 3,015 m, 8,122 m and 11,600 m), seepages in the closed sluices (in six places, with siltation in three and vegetation in two places), defective shutters in the regulators (one place), breaches due to erosion of body wall (one place).

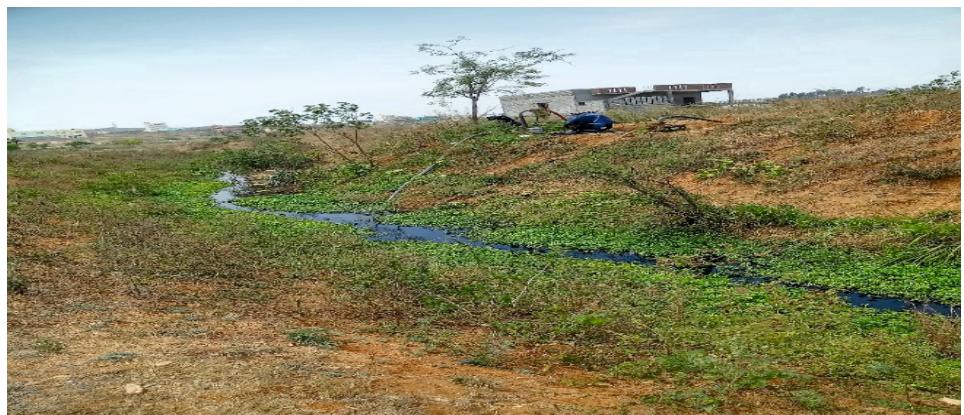
**Figure 6: Siltation with bushes in the lined channel**

- On account of illegal tapping of water, siltation, improper maintenance of channel, the realisation of water at the tail end was very meagre depriving water to the farmers in the tail end. It was noticed during Joint Inspection (17 March 2021) that the released water reached only
