Report of the Comptroller and Auditor General of India

Marine Logistics Operations in Oil and Natural Gas Corporation Limited

Union Government (Commercial)
Ministry of Petroleum and Natural Gas
No. 7 of 2019
(Performance Audit)

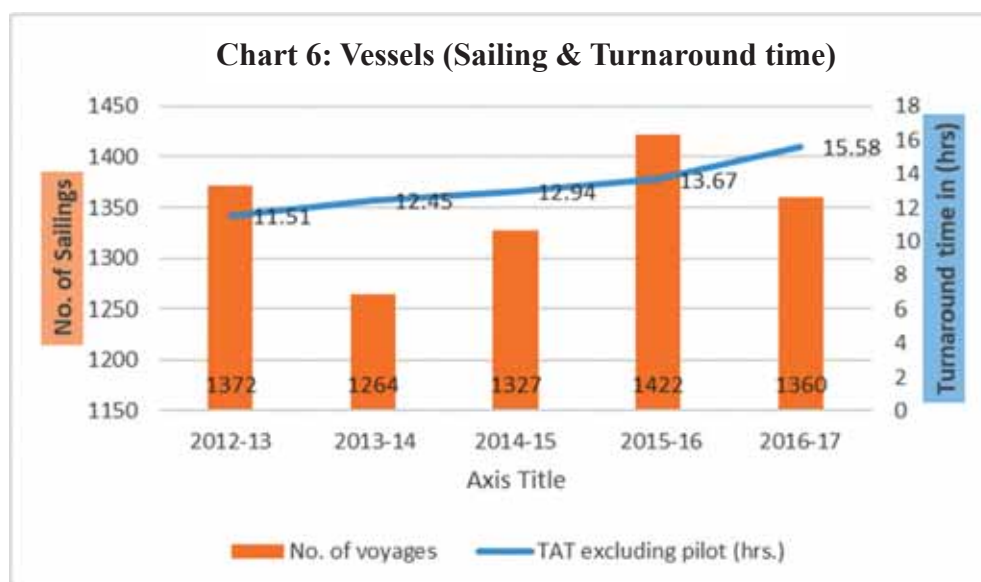
The global benchmark for TAT³² at a base was four to six hours³³. The TAT of vessel (owned/hired) being operated at NSB during the period 2012-13 to 2016-17 is presented in the Chart given below:

It may be seen from the chart that the TAT of vessels at NSB increased from 11.51 hours in 2012-13 to 15.58 hours in 2016-17. The number of voyages, however, varied during the period with the number peaking at 1,422 in 2015-16.

The extra operational cost incurred by the Company during the period from 2012-13 to 2016-17 due to failure in achieving global benchmark of six hours for TAT was assessed in audit at ₹154.63 crore. The details are at **Annexure VIIA**.

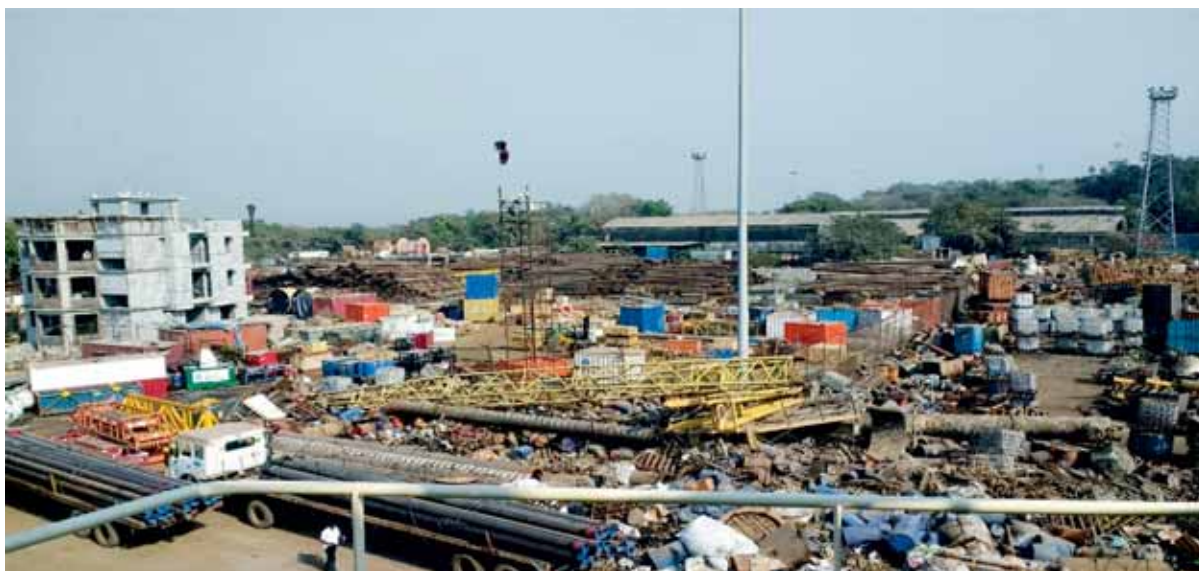
NSB Jetty

unloading process. NSB was also facing various constraints like shortage of space for material storage, shortage of material handling equipment and of skilled manpower.

Management stated (May/September 2017) that steps were being taken to upgrade the infrastructure for better coordination and supervision and better results. Fair wage policy was being implemented to motivate workers and to reduce the TAT. Ministry stated (December 2017) that the Company has agreed to take measures to improve the turnaround time.

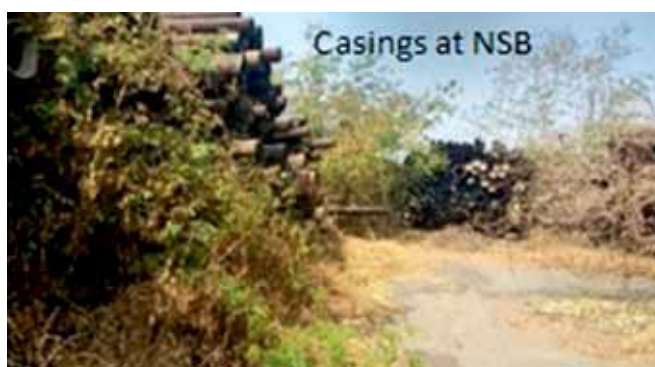
Proper storage and accounting of stores is part of sound inventory management. Examination of the practices adopted at NSB indicated that there was no SOP developed for storing and handling the material. This resulted in overstocking and the casing pipes, which formed the bulk of the inventory at NSB, being piled up without any demarcation.

Audit also observed that the Material Management group functioned only during office hours while the despatch of casing pipes and receipt of backload items were being carried out round the clock which can lead to non-accounting or delay in accounting of stores. The sheds/yards were operated by different stock holders. Backload materials were kept as a heap in the garden area, without any SAP MAT code, and irrespective of their condition, they were accounted as scrap.

Management while attributing the deficiencies to shortage of manpower stated (September 2017) that attempts were made to improve the storage practices. Segregation of casing pipes had been carried out and good pipes were taken in to custody of Material Management Department. During 2016-17 though physical verification of 'A' category items were carried out, no discrepancies were reported. Management admitted that receipt of casing pipes/drill pipes by Drilling Tool Yard Store (DTYS) had been discontinued for a year and since the assets are not geared for the new system, materials were kept in heaps at premises. Further, due to limitation/ shortage of sheds, materials of more than one stock holder were stored under one shed leading to lack of control. Construction of new sheds, pipe rack and installation of CCTV camera in store section were to be initiated.

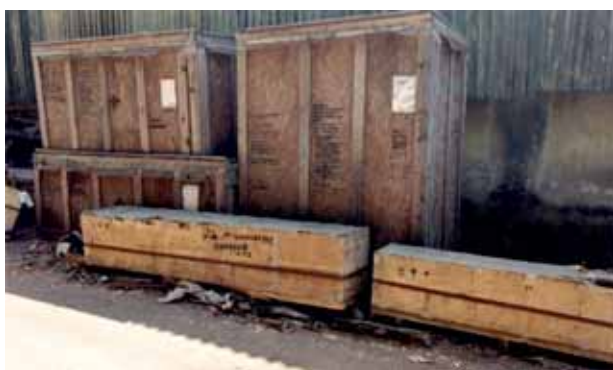
Items marked for storage in covered sheds lying in open

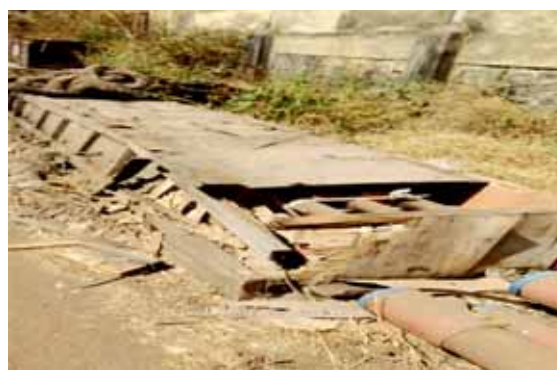
Unused casings lying in the open
